**Flood Control Project Maintenance
Levee Inspections**

Fall 2018 Levee Maintenance Deficiency Summary Report

Sacramento River Basin

**Flood Control Project Maintenance
Levee Inspections****LMA District Cover Sheet****Fall 2018 Levee Inspection Results****Tehama County Flood Control and Water Conservation District**

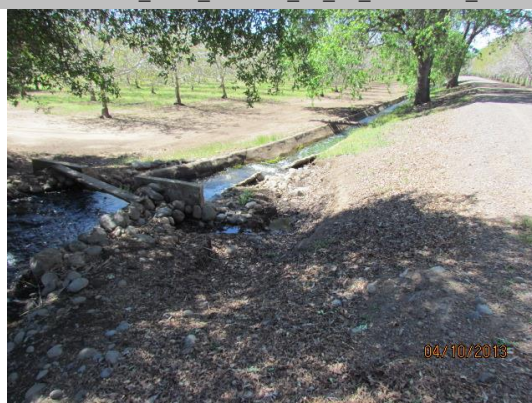
Photo 1 of 1 : FA_2018_NA0019_78_17_20180905_00005.jpg

LM Start	0.01	Rating **	M	Issue No.	17
LM End	0.01	Issue Type +	Ma	Location *	LS
Category	Earthen Levee			GPS Latitude/Longitude	
				Start	End
Item	Erosion / Bank Caving			39.973111 °	39.973111 °
				-121.980466 °	-121.980466 °
DWR ID	DWR_NA0019_01_s_2013_17				
Comment Code					
E1 : Note and monitor erosion site.					
Inspector Comment

View of the erosion along the landside slope.

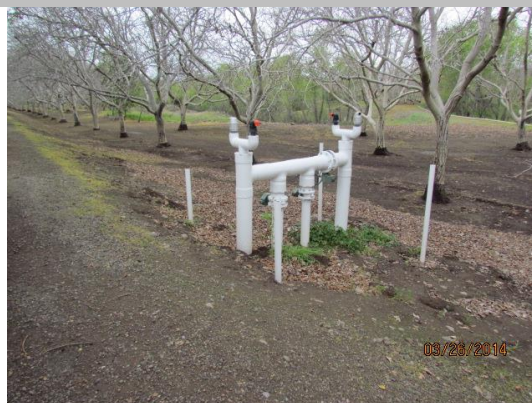
Photo 1 of 1 : FA_2018_NA0019_78_275_20180905_00018.jpg

LM Start	0.02	Rating **	U	Issue No.	275
LM End	0.02	Issue Type +	En	Location *	WS
Category	Earthen Levee			GPS Latitude/Longitude	
				Start	End
Item	Encroachments			39.973128 °	39.973128 °
				-121.980734 °	-121.980734 °
DWR ID	DWR_NA0019_01_s_2014_275				
Comment Code					
PI : Pipe					
Inspector Comment

View of the irrigation pipe along the waterside slope.

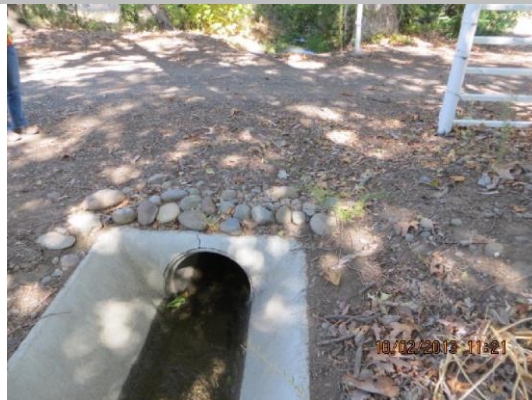
Photo 2 of 3 : UCIP_FA_2018_39839_39062.jpg

LM Start	0.49	Rating **	M	Issue No.	279
LM End	0.49	Issue Type +	En	Location *	
Category	Supplemental			GPS Latitude/Longitude	
				Start	End
Item	DWR UCIP Field Study			39.972280 °	39.972280 °
				-121.989227 °	-121.989227 °
DWR ID	24686				
Comment Code					
Inspector Comment					
FS_ID:39839 DS_ID:24686 EP_NO: N/A Repair Type: Non-Urgent Crossing Status: Found UCIP Comments: No permit identified for crossing. FIELD_STRUCT_DESC: 20-inch reinforced concrete irrigation pipe through the levee, 2 feet below the crown. Concrete canal and distribution structure with slat boards on the landside (LS) shoulder. FS Date: 10/2/2013

Concrete headwall at canal on LS shoulder.

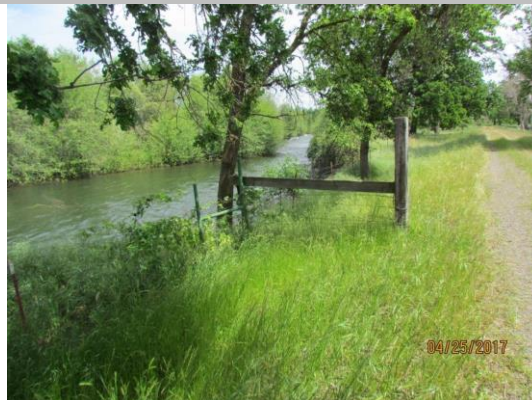
Photo 1 of 1 : FA_2018_NA0019_78_42_20180905_00016.jpg

LM Start	1.55	Rating **	A/W	Issue No.	42
LM End	1.58	Issue Type +	Ma	Location *	WS
Category	Earthen Levee			GPS Latitude/Longitude	
				Start	End
Item	Erosion / Bank Caving			39.969193 °	39.969052 °
				-122.008458 °	-122.008920 °
DWR ID	DWR_NA0019_01_s_2017_42				
Comment Code					
E2 : Schedule repair of erosion site prior to the next inspection.					
Inspector Comment					
Repair the erosion along the water side toe.

View of the erosion along the waterside toe.

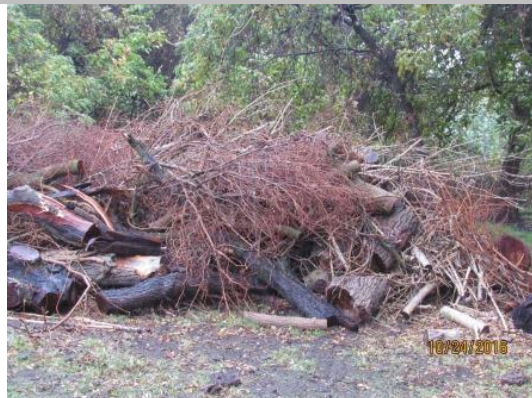
Photo 1 of 1 : FA_2018_NA0019_78_31_20180905_00010.jpg

LM Start	1.66	Rating **	M	Issue No.	31
LM End	1.66	Issue Type +	En	Location *	WS
Category	Earthen Levee			GPS Latitude/Longitude	
				Start	End
Item	Encroachments			39.968670 °	39.968670 °
				-122.010271 °	-122.010271 °
DWR ID	DWR_NA0019_01_f_2016_31				
Comment Code					
PR : Prunings					
Inspector Comment					
Remove prunings from the landside toe.

View of the prunings along the waterside slope.

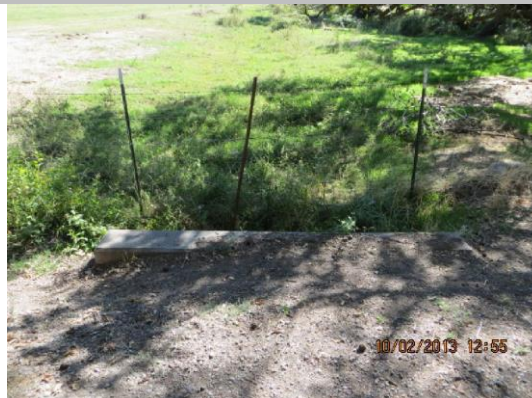
Photo 2 of 3 : UCIP_FA_2018_53391_36921.jpg

Comment Code						
Inspector Comment						
FS_ID:53391 DS_ID:20770 EP_NO: N/A Repair Type: Urgent Crossing Status: Found UCIP Comments: 10/15/2018 Flap gate on WS end stuck open. Lower part of pipe is silted that makes impossible flap gate to fully close. Needs sediment cleanup around pipe outlet on WS. (O.Yakimov - DWR)12/05/2016 Sediment buildup inside pipe (see photo) and sediment buildup on WS blocking flap gate. Crossing has been downgraded from Urgent to Non-Urgent crossing was closed on both WS and LS. (O. Magana - DWR UCIP)10/02/2013 Flapgate blocked by soil buildup. (W. Wylie - DWR UCIP) FIELD_STRUCT_DESC: 24-inch steel drainage pipe through the levee, 1.5 feet below the crown. Flap gate on the waterside (WS) toe. [Additional Reference(s): DWR Levee Log, 1992. USACE Sacramento O&M Manual Unit 509, March 1957, As-built drawings available 50-4-2394 (Station 185+40)]. FS Date: 10/15/2018 3:31:56 PM

Concrete headwall on LS toe.

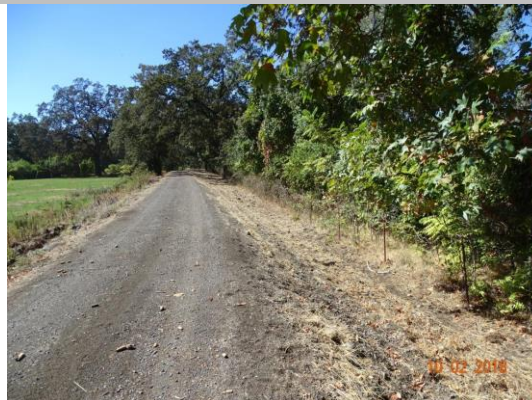
Photo 1 of 1 : FA_2018_NA0019_78_40_20181008_00062.jpg

LM Start	1.77	Rating **	A	Issue No.	40
LM End	1.85	Issue Type +	Ma	Location *	WS
Category	Earthen Levee			GPS Latitude/Longitude	
				Start	End
Item	Vegetation			39.969528 °	39.969210 °
				-122.011982 °	-122.013383 °
DWR ID	DWR_NA0019_01_f_2018_40				
Comment Code					
V1 : Control annual grass and weeds on the levee slopes and easements.					
Inspector Comment					
The vegetation was removed from the waterside slope.

View of the remove vegetation from the waterside slope.

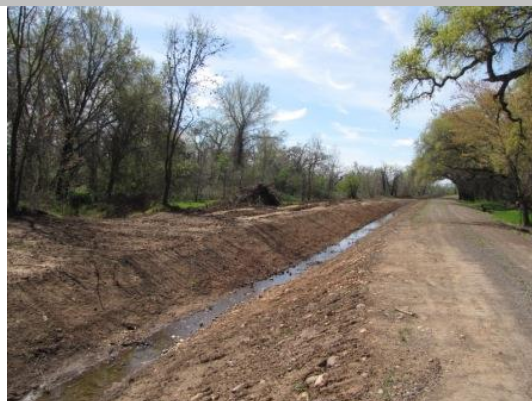
Photo 2 of 2 : FA_2018_NA0019_78_2_20180905_00002.jpg

LM Start	1.79	Rating **	U	Issue No.	2
LM End	2.22	Issue Type +	En	Location *	LS
Category	Earthen Levee			GPS Latitude/Longitude	
				Start	End
Item	Encroachments			39.969443 °	39.966921 °
				-122.012261 °	-122.019469 °
DWR ID	DWR_NA0019_01_s_2012_2				
Comment Code					
DT : Ditch					
Inspector Comment					
Repair the cleaned out irrigation ditch along the landside toe.

View of an agricultural ditch along the levee toe.

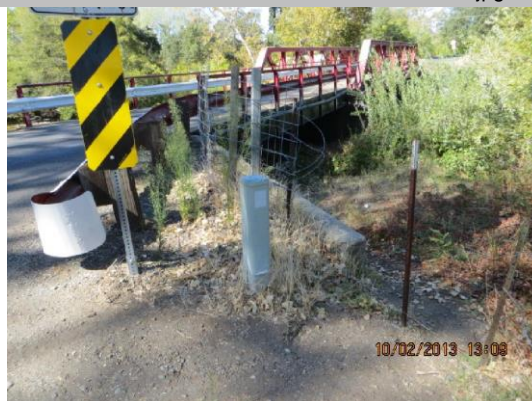
Photo 2 of 3 : UCIP_FA_2018_39837_39066.jpg

LM Start	1.88	Rating **	M	Issue No.	281 (cont)	
LM End	1.88	Issue Type +	En	Location *		
Category	Supplemental			GPS Latitude/Longitude		
				Start	End	
Item	DWR UCIP Field Study			39.969156°	39.969156°	
				-122.013809°	-122.013809°	
DWR ID	24690					
Comment Code						
Inspector Comment						
FS_ID:39837 DS_ID:24690 EP_NO: N/A Repair Type: Non-Urgent Crossing Status: Found UCIP Comments: No permit identified for this crossing. FIELD_STRUCT_DESC: 4-inch steel communications conduit through the levee, at an unknown depth. Junction box off the landside (LS) toe next to JP and roadway. Conduit visible on upstream side of bridge at Deer Creek crossing. FS Date: 10/2/2013

Communication box on WS shoulder.

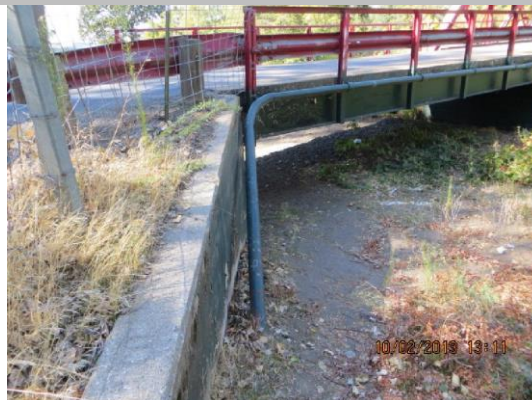
Photo 3 of 3 : UCIP_FA_2018_39837_39065.jpg

Conduit visible on WS slope and at upstream side of bridge.

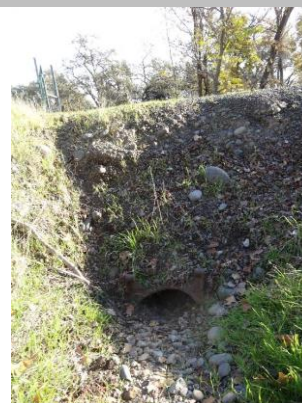
Photo 3 of 3 : UCIP_FA_2018_53392_76787.jpg

Comment Code						
Inspector Comment						
FS_ID:53392 DS_ID:20769 EP_NO: N/A Repair Type: Urgent Crossing Status: Found UCIP Comments: 10/15/2018 Flapgate on WS is missing, pipe partially blocked with silt. (O.Yakimov - DWR)12/05/2016 same as last inspection. Crossing remains "Urgent" WS opened during flood season due to damaged flap gate. (O. Magana - DWR UCIP)10/02/2013 Flapgate missing or burried on WS toe. Pipe partially blocked by soil on WS toe. (W. Wylie - DWR UCIP) FIELD_STRUCT_DESC: 24-inch corrugated metal drainage pipe through the levee, 7 feet below the crown. Flap gate located on the waterside (WS) end. A 5-foot by 5-foot concrete control structure located on the landside (LS) toe. [Additional Reference(s): DWR Levee Log, 1992. USACE Sacramento O&M Manual Unit 509, March 1957, As-built drawing no. 50-4-2394 (Station 176+10)]. FS Date: 10/15/2018 3:33:50 PM

Damage flap gate visible on WS.

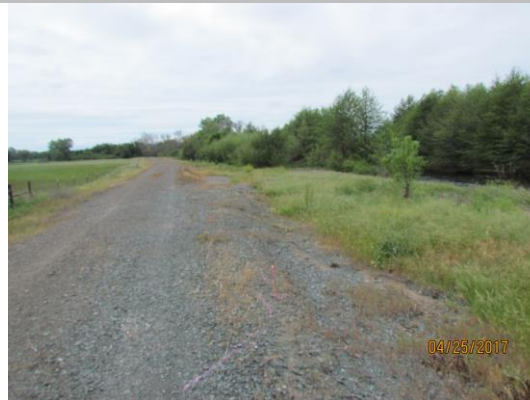
Photo 1 of 1 : FA_2018_NA0019_78_39_20180905_00014.jpg

LM Start	2.53	Rating **	M	Issue No.	39
LM End	2.53	Issue Type +	Ma	Location *	WS
Category	Earthen Levee			GPS Latitude/Longitude	
				Start	End
Item	Erosion / Bank Caving			39.966675 °	39.966675 °
				-122.024988 °	-122.024988 °
DWR ID	DWR_NA0019_01_s_2017_39				
Comment Code					
E2 : Schedule repair of erosion site prior to the next inspection.					
Inspector Comment					
Repair the erosion along the water side slope.

View of erosion along the waterside slope.

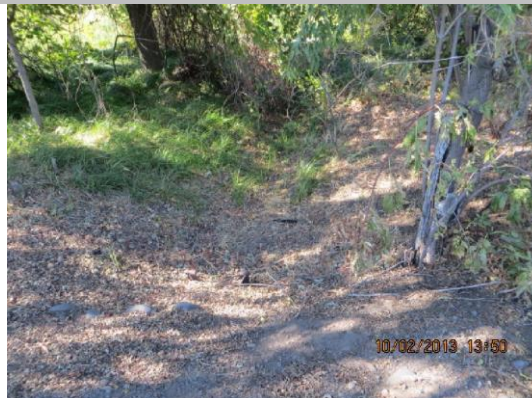
Photo 1 of 2 : UCIP_FA_2018_22824_38946.jpg

LM Start	2.86	Rating **	M	Issue No.	284	
LM End	2.86	Issue Type +	Ma	Location *		
Category	Supplemental			GPS Latitude/Longitude		
				Start	End	
Item	DWR UCIP LMA Responsibility			39.963938 °	39.963938 °	
				-122.030128 °	-122.030128 °	
DWR ID	20767					
Comment Code						
Inspector Comment						
FS_ID:22824						
DS_ID:20767						
EP_NO: N/A						
Repair Type: Non-Urgent						
Crossing Status: Found						
UCIP Comments: Pipe blocked by soil.						
FIELD_STRUCT_DESC: 24-inch corrugated metal drainage pipe through the levee, 6 feet below the crown. Flap gate on the waterside (WS) end. [Additional Reference(s): DWR Levee Log, 1992. USACE Sacramento O&M Manual 509, March 1957, (Assumed Station 137+50) Drawing No. 50-4-2394].						
FS Date: 10/2/2013

Flapgate blocked by soil and debris.

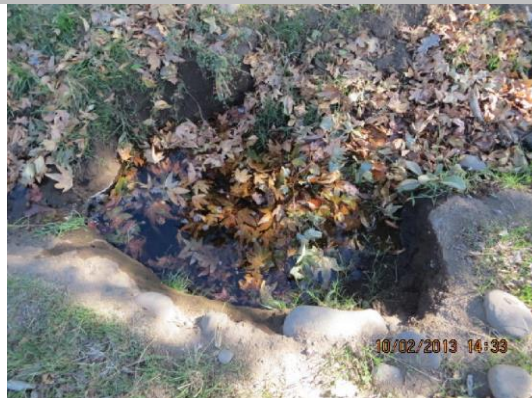
Photo 2 of 3 : UCIP_FA_2018_22825_38951.jpg

LM Start	3.29	Rating **	M	Issue No.	285 (cont)	
LM End	3.29	Issue Type +	En	Location *		
Category	Supplemental			GPS Latitude/Longitude		
				Start	End	
Item	DWR UCIP Field Study			39.947484 °	39.947484 °	
				-122.049011 °	-122.049011 °	
DWR ID	20766					
Comment Code						
Inspector Comment						
FS_ID:22825						
DS_ID:20766						
EP_NO: N/A						
Repair Type: Non-Urgent						
Crossing Status: Indicator Found						
UCIP Comments: Pipe buried. Water flows to low spot and dissapears, but pipe not visible.						
FIELD_STRUCT_DESC: 24-inch pipe through the levee 8-feet below the crown, flap gate on waterward end. Originally included in O+M manual (1957). As-built drawing No. 50-4-2394.						
FS Date: 10/2/2013

Low spot with water on LS toe.

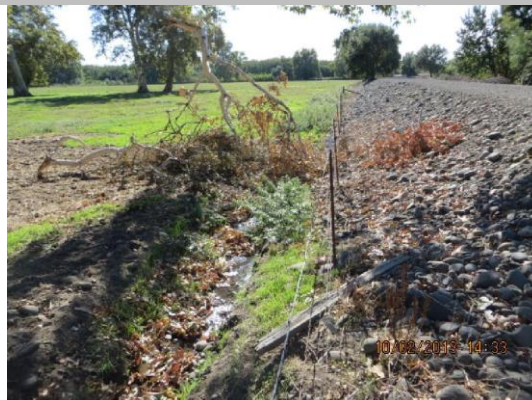
Photo 3 of 3 : UCIP_FA_2018_22825_38953.jpg

Low spot on LS toe where water dissappears from levee toe. Unable to identify exact location of pipe on LS toe.

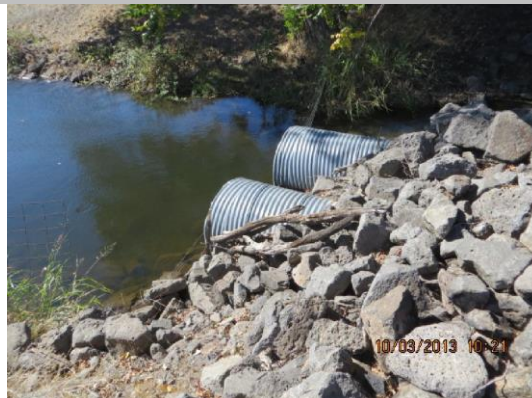
Photo 1 of 3 : UCIP_FA_2018_23007_39070.jpg

LM Start	3.59	Rating **	M	Issue No.	286
LM End	3.59	Issue Type +	En	Location *	
Category	Supplemental			GPS Latitude/Longitude	
				Start	End
Item	DWR UCIP Field Study			39.945964 °	39.945964 °
				-122.054229 °	-122.054229 °
DWR ID	24687				
Comment Code					
Inspector Comment					
FS_ID:23007 DS_ID:24687 EP_NO: N/A Repair Type: Non-Urgent Crossing Status: Found UCIP Comments: No permit identified for this crossing. FIELD_STRUCT_DESC: 48-inch corrugated metal drainage pipe through the levee, 6 feet below the crown. Flap gate on the waterside (WS) end. FS Date: 10/3/2013

Pipe visible on LS toe.

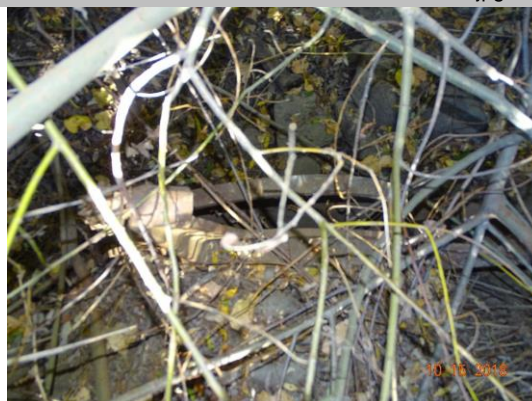
Photo 1 of 3 : UCIP_FA_2018_53393_78194.jpg

Gap is visible between flap gate and pipe.

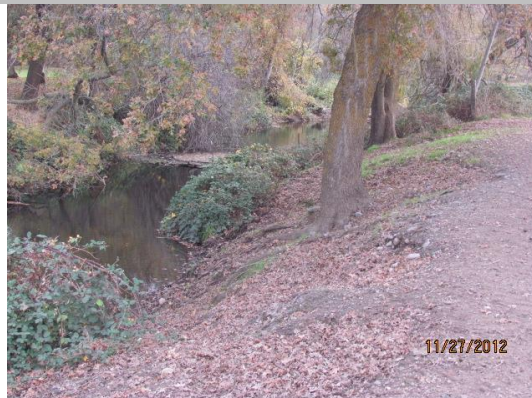
Photo 1 of 1 : FA_2018_NA0019_78_15_20180905_00003.jpg

LM Start	3.68	Rating **	M	Issue No.	15
LM End	3.68	Issue Type +	Ma	Location *	LS
Category	Earthen Levee			GPS Latitude/Longitude	
				Start	End
Item	Slope Stability			39.945045°	39.945045°
				-122.053469°	-122.053469°
DWR ID	DWR_NA0019_01_f_2012_15				
Comment Code					
S1 : Repair slope instability.					
Inspector Comment

View of the erosion caused by livestock along the landside slope.

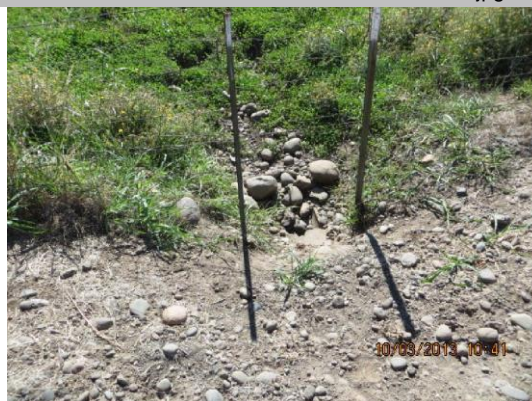
Photo 1 of 3 : UCIP_FA_2018_23094_39307.jpg

LM Start	3.75	Rating **	M	Issue No.	289
LM End	3.75	Issue Type +	En	Location *	
Category	Supplemental			GPS Latitude/Longitude	
				Start	End
Item	DWR UCIP Field Study			39.944460 °	39.944460 °
				-122.053930 °	-122.053930 °
DWR ID	20763				
Comment Code					
Inspector Comment					
FS_ID:23094 DS_ID:20763 EP_NO: N/A Repair Type: Non-Urgent Crossing Status: Found UCIP Comments: Erosion on WS toe. FIELD_STRUCT_DESC: 12-inch concrete drainage pipe, through the levee, 2-feet below the crown. FS Date: 10/3/2013

Concrete pipe at inlet on LS toe.

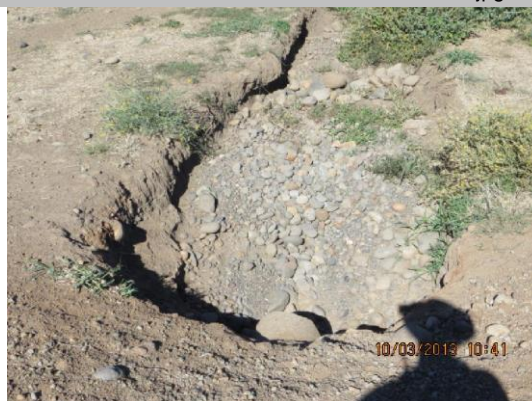
Photo 2 of 3 : UCIP_FA_2018_23094_39306.jpg

Concrete pipe at outlet on WS toe.

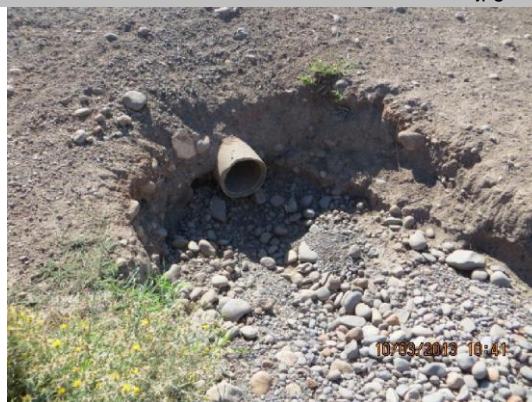
Photo 3 of 3 : UCIP_FA_2018_23094_39305.jpg

Concrete pipe at outlet on WS toe.

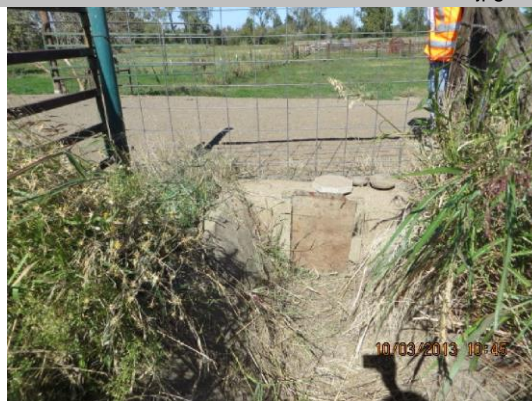
Photo 1 of 3 : UCIP_FA_2018_23092_39298.jpg

LM Start	3.75	Rating **	M	Issue No.	290	
LM End	3.75	Issue Type +	En	Location *		
Category	Supplemental			GPS Latitude/Longitude		
				Start	End	
Item	DWR UCIP Field Study			39.944426 °	39.944426 °	
				-122.054045 °	-122.054045 °	
DWR ID	24691					
Comment Code						
Inspector Comment						
FS_ID:23092						
DS_ID:24691						
EP_NO: N/A						
Repair Type: Non-Urgent						
Crossing Status: Found						
UCIP Comments: Outlet substantially blocked at WS toe. No permit identified for this crossing.						
FIELD_STRUCT_DESC: 10-inch reinforced concrete irrigation pipe through the levee, 2 feet below the crown. Slide gate at terminal end of concrete channel on the landside (LS) shoulder.						
FS Date: 10/3/2013

Slide panel at inlet on LS shoulder.

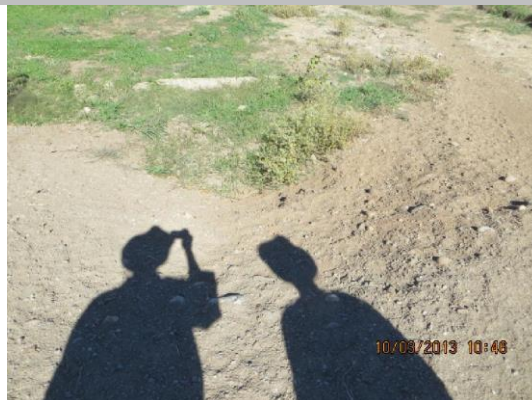
Photo 2 of 3 : UCIP_FA_2018_23092_39297.jpg

Pipe outlet on WS toe.

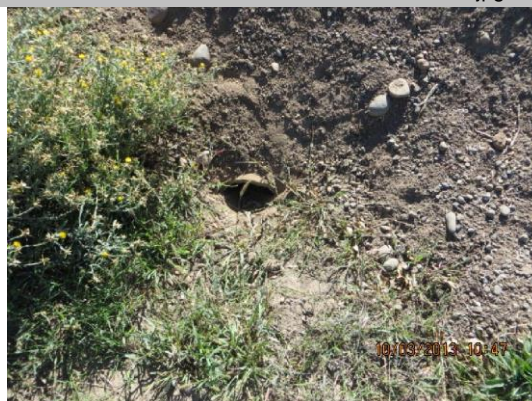
Photo 3 of 3 : UCIP_FA_2018_23092_39296.jpg

Pipe outlet on WS toe.

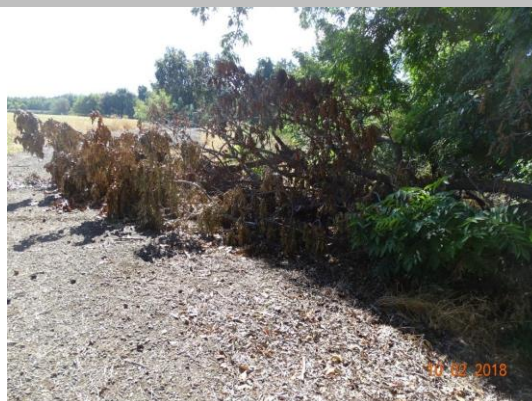
Photo 1 of 1 : FA_2018_NA0019_78_44_20181008_00063.jpg

LM Start	3.99	Rating **	M	Issue No.	44
LM End	3.99	Issue Type +	En	Location *	WS
Category	Earthen Levee			GPS Latitude/Longitude	
				Start	End
Item	Encroachments			39.941990 °	39.941990 °
				-122.057140 °	-122.057140 °
DWR ID	DWR_NA0019_01_f_2018_44				
Comment Code					
TR : Tree or limb					
Inspector Comment

View of the tree limb along the waterside slope.

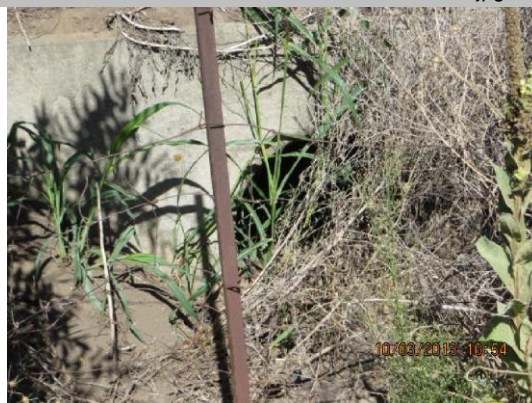
Photo 1 of 3 : UCIP_FA_2018_21741_36937.jpg

LM Start	4.03	Rating **	A/W	Issue No.	291
LM End	4.03	Issue Type +	Ma	Location *	
Category	Supplemental			GPS Latitude/Longitude	
				Start	End
Item	DWR UCIP LMA Responsibility			39.941574 °	39.941574 °
				-122.057597 °	-122.057597 °
DWR ID	20760				
Comment Code					
Inspector Comment					
FS_ID:21741					
DS_ID:20760					
EP_NO: N/A					
Repair Type: No Action Needed					
Crossing Status: Found					
UCIP Comments:					
FIELD_STRUCT_DESC: 24-inch corrugated metal drainage pipe					
through the levee, 5 feet below the crown. Flap gate on the waterside					
(WS) end. Headwalls on both sides of levee. [Additional Reference(s):					
DWR Levee Log, 1992. USACE Sacramento O&M Manual 509, March					
1957, (Assumed Station 5+00) Drawing No. 50-4-2394].					
FS Date: 10/3/2013

Pipe and concrete headwall on LS toe.

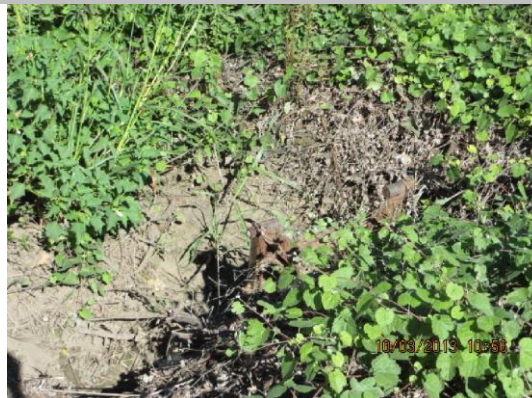
Photo 2 of 3 : UCIP_FA_2018_21741_36936.jpg

Flapgate on WS toe.

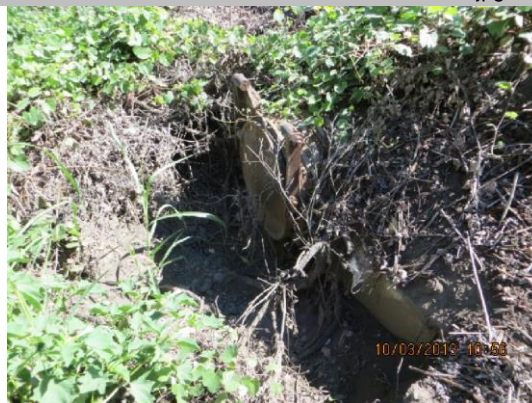
Photo 3 of 3 : UCIP_FA_2018_21741_36935.jpg

Flapgate and concrete headwall on WS toe.

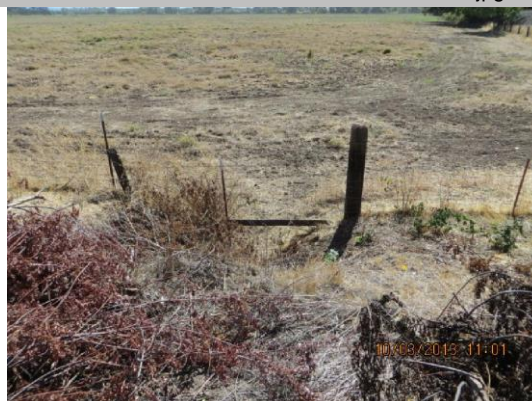
Photo 1 of 3 : UCIP_FA_2018_53395_36942.jpg

Comment Code						
Inspector Comment						
FS_ID:53395 DS_ID:20762 EP_NO: N/A Repair Type: Urgent Crossing Status: Found UCIP Comments: 10/15/2018 Missing flap gate at WS end of the pipe. Pipe is partially blocked with silt. Updated coordinates and CLM. (O.Yakimov - DWR)12/05/2016 unable to complete inspection -- unable to locate. (O. Magana - DWR UCIP)10/03/2013 Gate missing from WS toe. (W. Wylie - DWR UCIP) FIELD_STRUCT_DESC: 24-inch corrugated metal drainage pipe through the levee, 5.5 feet below the crown. Flap gate located on the waterside (WS) end. Concrete headwall located on the landside (LS) toe. [Additional Reference(s): DWR Levee Log, 1992. USACE Sacramento O&M Manual Unit 509, March 1957, As-built drawing no. 50-4-2394 (Station 0+65)]. FS Date: 10/15/2018 3:37:24 PM

Inlet on LS toe.

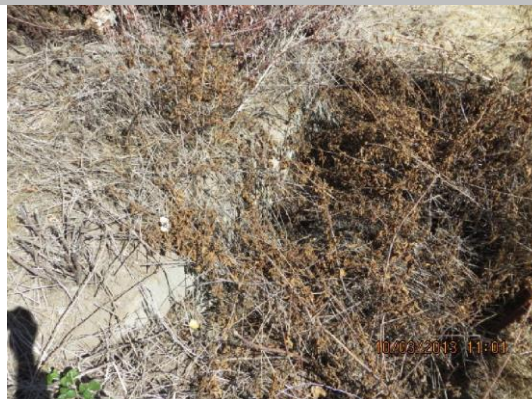
Photo 2 of 3 : UCIP_FA_2018_53395_36941.jpg

Concrete headwall at inlet on LS toe.

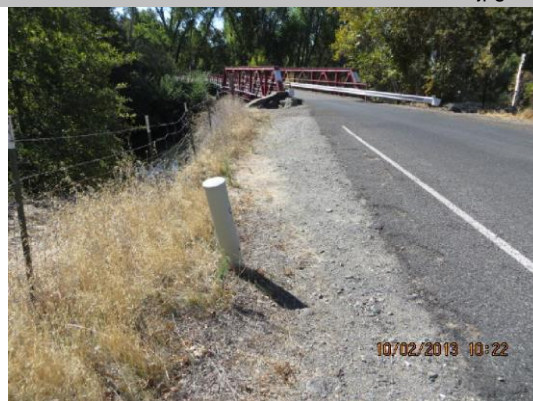
Photo 1 of 3 : UCIP_FA_2018_40789_39057.jpg

LM Start	0.31	Rating **	M	Issue No.	20
LM End	0.31	Issue Type +	En	Location *	
Category	Supplemental			GPS Latitude/Longitude	
				Start	End
Item	DWR UCIP Field Study			39.970256 °	39.970256 °
				-122.014471 °	-122.014471 °
DWR ID	24683				
Comment Code					
Inspector Comment					
FS_ID:40789 DS_ID:24683 EP_NO: N/A Repair Type: Non-Urgent Crossing Status: Found UCIP Comments: No permit identified for this crossing. FIELD_STRUCT_DESC: 4-inch galvanized iron communications conduit through the levee, at an unknown depth. Pipe visible on upstream side of bridge. FS Date: 10/2/2013

Communication line access box on WS shoulder.

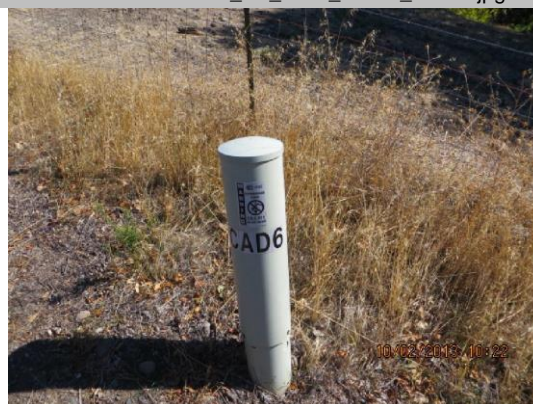
Photo 2 of 3 : UCIP_FA_2018_40789_39056.jpg

Communication line access box on WS shoulder.

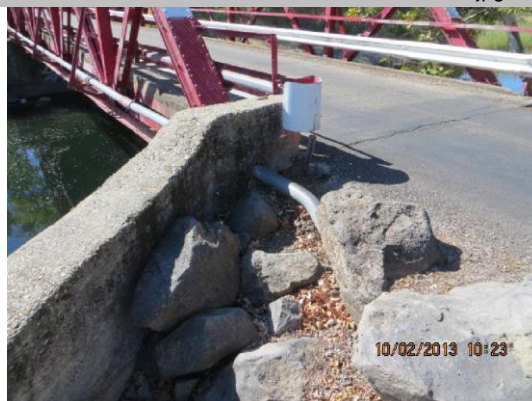
Photo 3 of 3 : UCIP_FA_2018_40789_39055.jpg

LM Start	0.31	Rating **	M	Issue No.	20 (cont)	
LM End	0.31	Issue Type +	En	Location *		
Category	Supplemental			GPS Latitude/Longitude		
				Start	End	
Item	DWR UCIP Field Study			39.970256 °	39.970256 °	
				-122.014471 °	-122.014471 °	
DWR ID	24683					
Comment Code						
Inspector Comment						
FS_ID:40789						
DS_ID:24683						
EP_NO: N/A						
Repair Type: Non-Urgent						
Crossing Status: Found						
UCIP Comments: No permit identified for this crossing.						
FIELD_STRUCT_DESC: 4-inch galvanized iron communications						
conduit through the levee, at an unknown depth. Pipe visible on						
upstream side of bridge.						
FS Date: 10/2/2013

Communication line conduit visible on upstream side of bridge at WS.

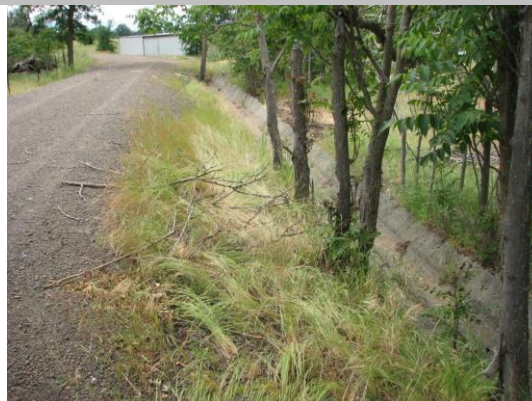
Photo 1 of 1 : FA_2018_NA0019_79_11_20180905_00004.jpg

LM Start	0.32	Rating **	M	Issue No.	11
LM End	0.34	Issue Type +	En	Location *	LS
Category	Earthen Levee			GPS Latitude/Longitude	
				Start	End
Item	Encroachments			39.970193 °	39.970188 °
				-122.014738 °	-122.015034 °
DWR ID	DWR_NA0019_02_s_2016_11				
Comment Code					
DT : Ditch					
Inspector Comment					
Concrete-lined.

View of a concrete-lined ditch along the levee toe.

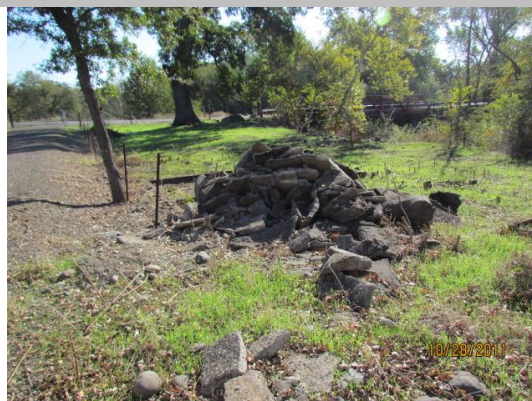
Photo 1 of 1 : FA_2018_NA0019_79_4_20180905_00002.jpg

LM Start	0.34	Rating **	M	Issue No.	4
LM End	0.34	Issue Type +	Ma	Location *	WS
Category	Earthen Levee			GPS Latitude/Longitude	
				Start	End
Item	Encroachments			39.970210 °	39.970210 °
				-122.015198 °	-122.015198 °
DWR ID	DWR_NA0019_02_s_2012_4				
Comment Code					
DE : Debris					
Inspector Comment

View of the concrete pile along the waterside toe.

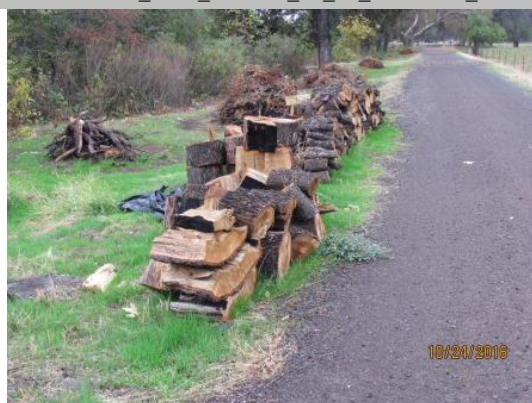
Photo 1 of 1 : FA_2018_NA0019_79_14_20180905_00007.jpg

LM Start	0.35	Rating **	M	Issue No.	14
LM End	0.35	Issue Type +	En	Location *	WS
Category	Earthen Levee			GPS Latitude/Longitude	
				Start	End
Item	Encroachments			39.970153 °	39.970153 °
				-122.015194 °	-122.015194 °
DWR ID	DWR_NA0019_02_f_2016_14				
Comment Code					
FW : Firewood					
Inspector Comment

View of the firewood along the waterside slope.

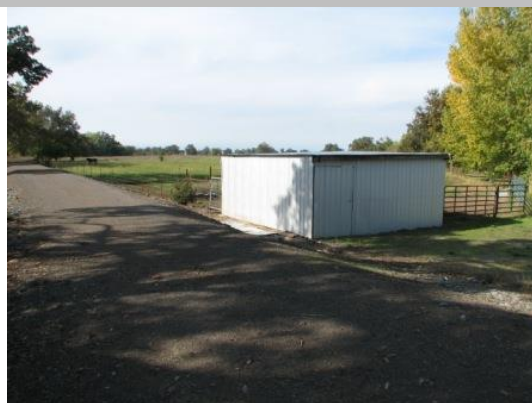
Photo 1 of 1 : FA_2018_NA0019_79_7_20180905_00003.jpg

LM Start	0.35	Rating **	M	Issue No.	7
LM End	0.35	Issue Type +	En	Location *	LS
Category	Earthen Levee			GPS Latitude/Longitude	
				Start	End
Item	Encroachments			39.970117 °	39.970117 °
				-122.015365 °	-122.015365 °
DWR ID	DWR_NA0019_02_s_2012_7				
Comment Code					
BU : Building					
Inspector Comment

View of a building along the levee toe.

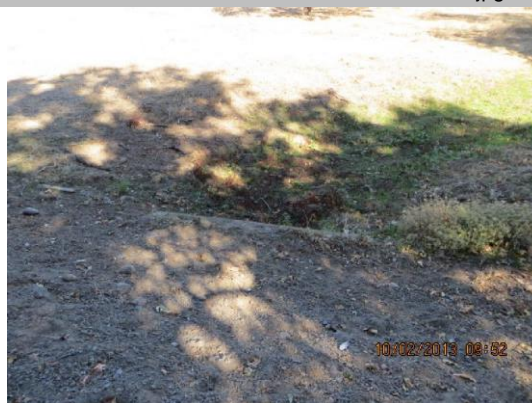
Photo 1 of 3 : UCIP_FA_2018_51442_36902.jpg

Comment Code						
Inspector Comment						
FS_ID:51442 DS_ID:20771 EP_NO: N/A Repair Type: Non-Urgent Crossing Status: Found UCIP Comments: 12/05/2016 Crossing has been downgraded from Urgent to Non-Urgent some debris blocking proper function of flapgate on WS. Recommend clearing debris from WS for flapgate to function properly. (O. Magana - DWR UCIP)10/01/2013 Debris blocking proper function of flapgate on WS toe. (W. Wylie - DWR UCIP) FIELD_STRUCT_DESC: 24-inch steel drainage pipe through the levee, 8.3 feet below the crown. Flap gate located on the waterside (WS) end. Concrete headwall located on the landside (LS). [Additional Reference(s): DWR Levee Log, 1992. USACE Sacramento O&M Manual Unit 509, March 1957, Unit 510, April 1963, Unit 511, May 1973, Unit 512, March 1964, Unit 513, December 1970, As-builts drawing 50-4-2394 (Station 155+40)]. FS Date: 12/5/2016

Concrete headwall at LS toe.

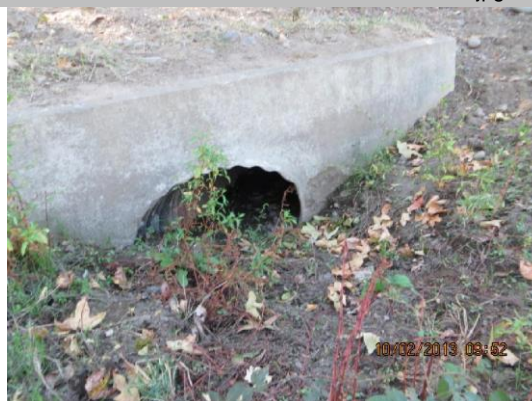
Photo 2 of 3 : UCIP_FA_2018_51442_36901.jpg

Concrete headwall at LS toe.

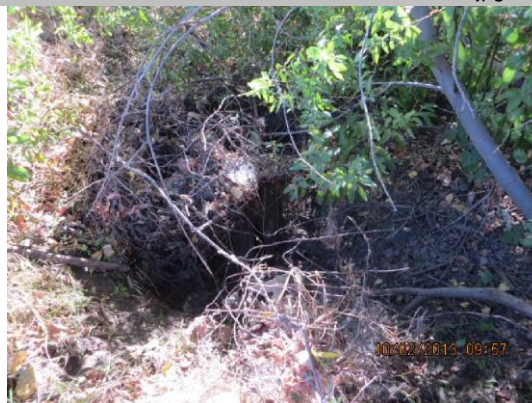
Photo 3 of 3 : UCIP_FA_2018_51442_36900.jpg

Outlet on WS toe.

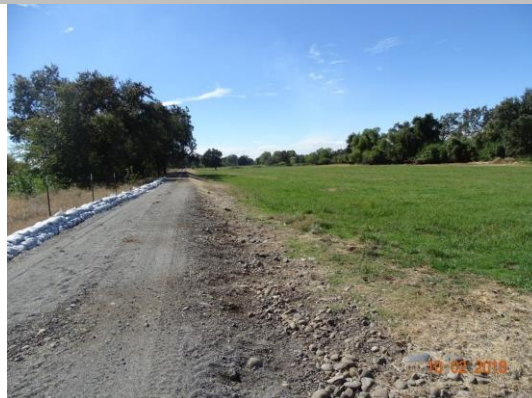
Photo 1 of 1 : FA_2018_NA0019_79_19_20181008_00016.jpg

LM Start	0.79	Rating **	A	Issue No.	19
LM End	1.31	Issue Type +	Ma	Location *	LS
Category	Earthen Levee			GPS Latitude/Longitude	
				Start	End
Item	Vegetation			39.968679 °	39.964525 °
				-122.022938 °	-122.031142 °
DWR ID	DWR_NA0019_02_f_2017_19				
Comment Code					
V2 : Remove the wild growth other than native grasses from the levee slopes.					
Inspector Comment					
The vegetation was removed from the landside slopes.

View of no vegetation along the landside slope.

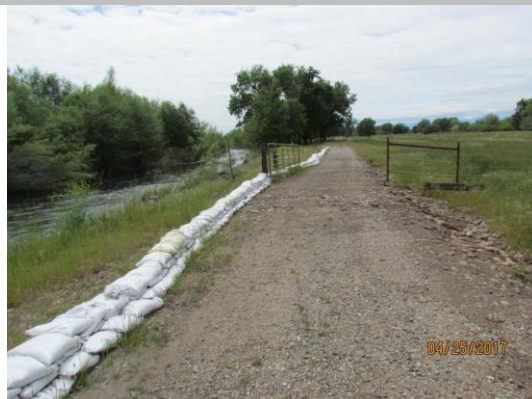
Photo 1 of 1 : FA_2018_NA0019_79_12_20180905_00005.jpg

LM Start	0.81	Rating **	M	Issue No.	12
LM End	0.85	Issue Type +	Ma	Location *	CR
Category	Earthen Levee			GPS Latitude/Longitude	
				Start	End
Item	Erosion / Bank Caving			39.968530 °	39.968248 °
				-122.023305 °	-122.023900 °
DWR ID	DWR_NA0019_02_s_2017_12				
Comment Code					
E2 : Schedule repair of erosion site prior to the next inspection.					
Inspector Comment					
Repair the crown roadway.

View of the erosion on the crown roadway.

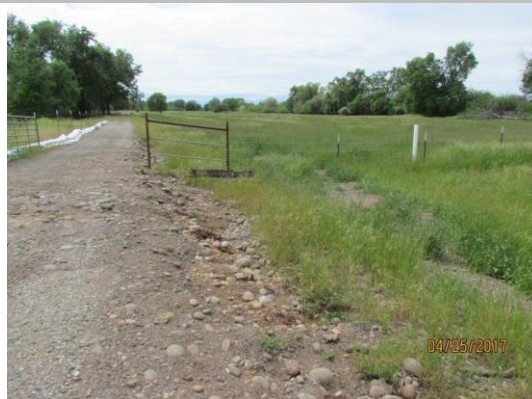
Photo 1 of 1 : FA_2018_NA0019_79_17_20180905_00008.jpg

LM Start	0.81	Rating **	M	Issue No.	17
LM End	0.85	Issue Type +	Ma	Location *	LS
Category	Earthen Levee			GPS Latitude/Longitude	
				Start	End
Item	Erosion / Bank Caving			39.968530 °	39.968248 °
				-122.023305 °	-122.023900 °
DWR ID	DWR_NA0019_02_s_2017_17				
Comment Code					
E2 : Schedule repair of erosion site prior to the next inspection.					
Inspector Comment					
Repair the erosion along the landside slope.

View of the erosion along the landside slope.

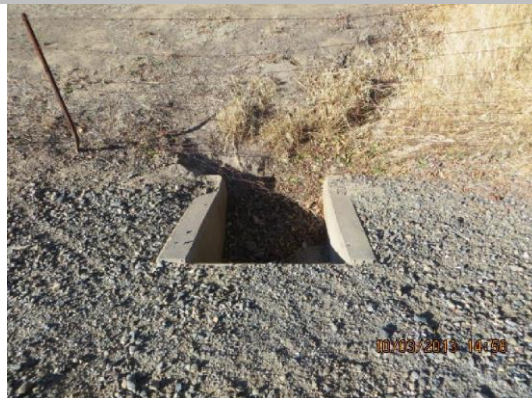
Photo 1 of 3 : UCIP_FA_2018_21795_37074.jpg

LM Start	0.25	Rating **	A/W	Issue No.	917
LM End	0.25	Issue Type +	Ma	Location *	
Category	Supplemental			GPS Latitude/Longitude	
				Start	End
Item	DWR UCIP LMA Responsibility			40.051604 °	40.051604 °
				-122.184431 °	-122.184431 °
DWR ID	20775				
Comment Code					
Inspector Comment					
FS_ID:21795 DS_ID:20775 EP_NO: N/A Repair Type: No Action Needed Crossing Status: Found UCIP Comments: FIELD_STRUCT_DESC: 24-inch corrugated metal drainage pipe through the levee, 4 feet below the crown. Flap gate and concrete U-shaped headwall on the waterside (WS) end. Concrete U-shaped headwall on the landside (LS) end. [Additional Reference(s): DWR Levee Log, 1992. USACE Sacramento O&M Manual 510, April 1963, (HLM 0.26) Drawing No. 50-4-3622]. FS Date: 10/3/2013

Concrete U-shaped headwall on LS toe.

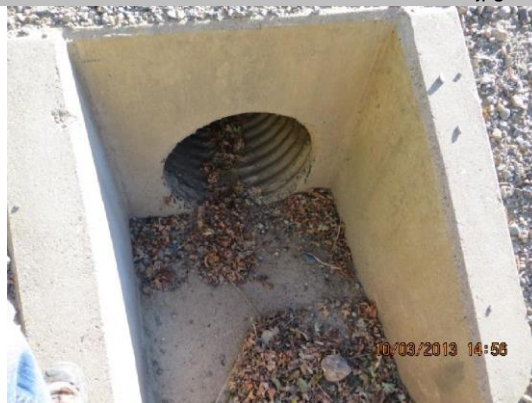
Photo 2 of 3 : UCIP_FA_2018_21795_37073.jpg

Concrete U-shaped headwall on LS toe.

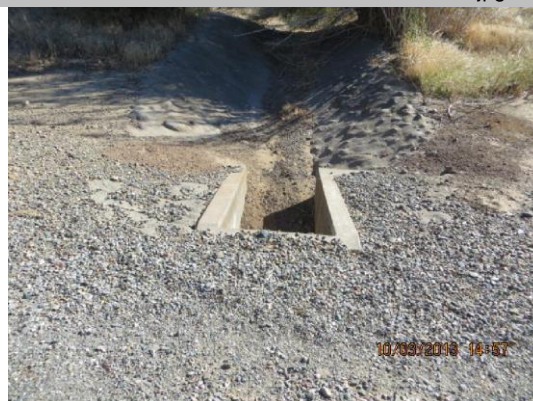
Photo 3 of 3 : UCIP_FA_2018_21795_37072.jpg

LM Start	0.25	Rating **	A/W	Issue No.	917 (cont)
LM End	0.25	Issue Type +	Ma	Location *	
Category	Supplemental			GPS Latitude/Longitude	
				Start	End
Item	DWR UCIP LMA Responsibility			40.051604 °	40.051604 °
				-122.184431 °	-122.184431 °
DWR ID	20775				
Comment Code					
Inspector Comment					
FS_ID:21795 DS_ID:20775 EP_NO: N/A Repair Type: No Action Needed Crossing Status: Found UCIP Comments: FIELD_STRUCT_DESC: 24-inch corrugated metal drainage pipe through the levee, 4 feet below the crown. Flap gate and concrete U-shaped headwall on the waterside (WS) end. Concrete U-shaped headwall on the landside (LS) end. [Additional Reference(s): DWR Levee Log, 1992. USACE Sacramento O&M Manual 510, April 1963, (HLM 0.26) Drawing No. 50-4-3622]. FS Date: 10/3/2013

Concrete U-shaped headwall on WS toe.

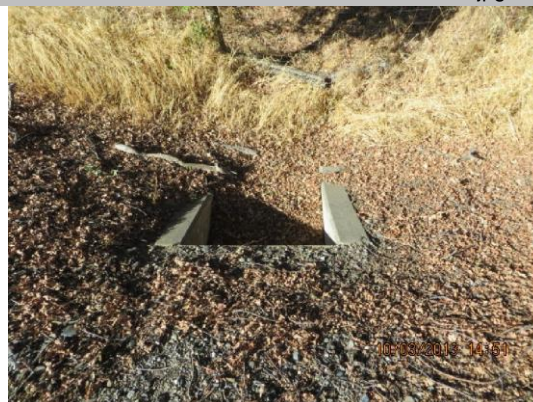
Photo 1 of 3 : UCIP_FA_2018_22826_38961.jpg

LM Start	0.38	Rating **	A/W	Issue No.	918	
LM End	0.38	Issue Type +	Ma	Location *		
Category	Supplemental			GPS Latitude/Longitude		
				Start		End
Item	DWR UCIP LMA Responsibility			40.051572 °		40.051572 °
				-122.182093 °		-122.182093 °
DWR ID	20776					
Comment Code						
Inspector Comment						
FS_ID:22826						
DS_ID:20776						
EP_NO: N/A						
Repair Type: No Action Needed						
Crossing Status: Found						
UCIP Comments:						
FIELD_STRUCT_DESC: 24-inch corrugated metal drainage pipe through the levee, 4.5 feet below the crown. Flap gate and concrete U-shaped headwall on the waterside (WS) end. Concrete U-shaped headwall on the landside (LS) end. [Additional Reference(s): DWR Levee Log, 1992. USACE Sacramento O&M Manual 510, April 1963, (HLM 0.39) Drawing No. 50-4-3622].						
FS Date: 10/3/2013

Concrete U-shaped headwall on LS toe.

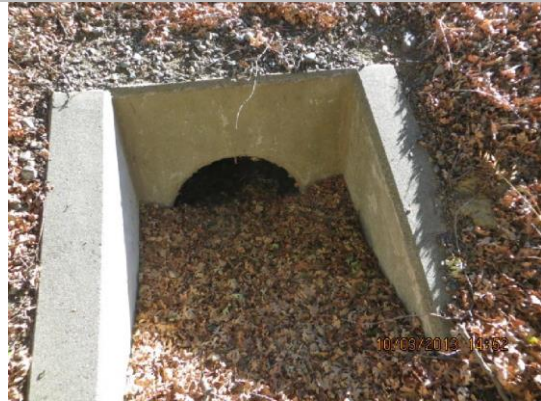
Photo 2 of 3 : UCIP_FA_2018_22826_38960.jpg

Concrete U-shaped headwall on LS toe.

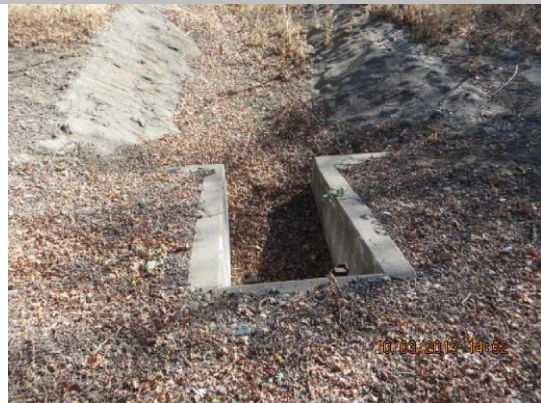
Photo 3 of 3 : UCIP_FA_2018_22826_38963.jpg

Concrete U-shaped headwall with concrete swale on WS toe.

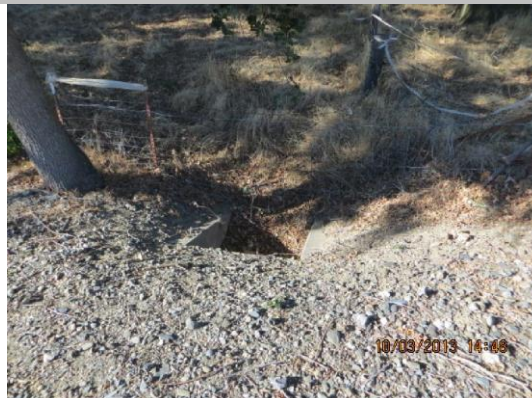
Photo 1 of 3 : UCIP_FA_2018_21793_37069.jpg

LM Start	0.51	Rating **	A/W	Issue No.	919
LM End	0.51	Issue Type +	Ma	Location *	
Category	Supplemental			GPS Latitude/Longitude	
				Start	End
Item	DWR UCIP LMA Responsibility			40.051211 °	40.051211 °
				-122.179663 °	-122.179663 °
DWR ID	20777				
Comment Code					
Inspector Comment					
FS_ID:21793					
DS_ID:20777					
EP_NO: N/A					
Repair Type: No Action Needed					
Crossing Status: Found					
UCIP Comments:					
FIELD_STRUCT_DESC: 24-inch corrugated metal drainage pipe through the levee, 5 feet below the crown. Flap gate and concrete U-shaped headwall on the waterside (WS) end. Concrete U-shaped headwall on the landside (LS) end. [Additional Reference(s): DWR Levee Log, 1992. USACE Sacramento O&M Manual 510, April 1963, (HLM 0.52) Drawing No. 50-4-3622].					
FS Date: 10/3/2013

Concrete U-shaped headwall on LS toe.

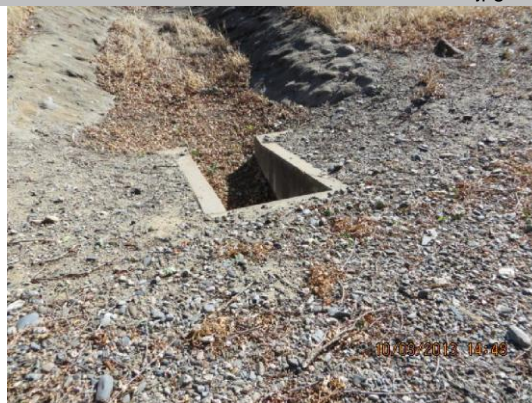
Photo 2 of 3 : UCIP_FA_2018_21793_37068.jpg

Concrete U-shaped headwall on WS toe.

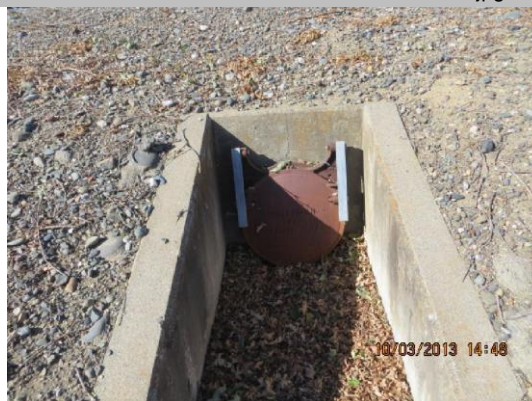
Photo 3 of 3 : UCIP_FA_2018_21793_37067.jpg

LM Start	0.51	Rating **	A/W	Issue No.	919 (cont)	
LM End	0.51	Issue Type +	Ma	Location *		
Category	Supplemental			GPS Latitude/Longitude		
				Start		End
Item	DWR UCIP LMA Responsibility			40.051211 °	40.051211 °	
				-122.179663 °	-122.179663 °	
DWR ID	20777					
Comment Code						
Inspector Comment						
FS_ID:21793 DS_ID:20777 EP_NO: N/A Repair Type: No Action Needed Crossing Status: Found UCIP Comments: FIELD_STRUCT_DESC: 24-inch corrugated metal drainage pipe through the levee, 5 feet below the crown. Flap gate and concrete U-shaped headwall on the waterside (WS) end. Concrete U-shaped headwall on the landside (LS) end. [Additional Reference(s): DWR Levee Log, 1992. USACE Sacramento O&M Manual 510, April 1963, (HLM 0.52) Drawing No. 50-4-3622]. FS Date: 10/3/2013

Concrete U-shaped headwall and flapgate on WS toe.

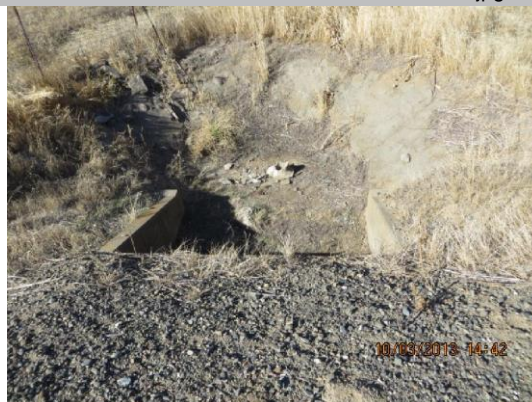
Photo 1 of 3 : UCIP_FA_2018_21792_37065.jpg

LM Start	0.64	Rating **	A/W	Issue No.	920	
LM End	0.64	Issue Type +	Ma	Location *		
Category	Supplemental			GPS Latitude/Longitude		
				Start		End
Item	DWR UCIP LMA Responsibility			40.051699 °		40.051699 °
				-122.177320 °		-122.177320 °
DWR ID	20778					
Comment Code						
Inspector Comment						
FS_ID:21792 DS_ID:20778 EP_NO: N/A Repair Type: No Action Needed Crossing Status: Found UCIP Comments: FIELD_STRUCT_DESC: 1 of 2: 36-inch corrugated metal drainage pipe through the levee, 8.6 feet below the crown. Flap gate and concrete U-shaped headwall on the waterside (WS) end. Concrete U-shaped headwall on the landside (LS) end. [Additional Reference(s): DWR Levee Log, 1992. USACE Sacramento O&M Manual 510, April 1963, (HLM 0.65) Drawing No. 50-4-3622]. FS Date: 10/3/2013

Concrete U-shaped headwall on LS toe.

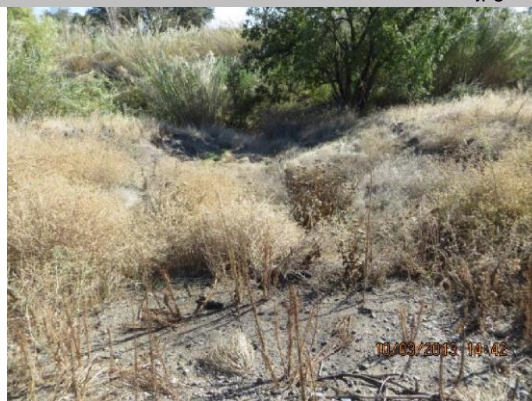
Photo 2 of 3 : UCIP_FA_2018_21792_37064.jpg

Concrete U-shaped headwall on WS toe.

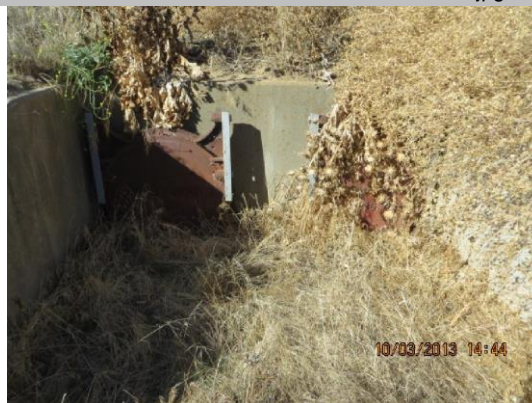
Photo 3 of 3 : UCIP_FA_2018_21792_37063.jpg

Concrete U-shaped headwall and flapgate on WS toe.

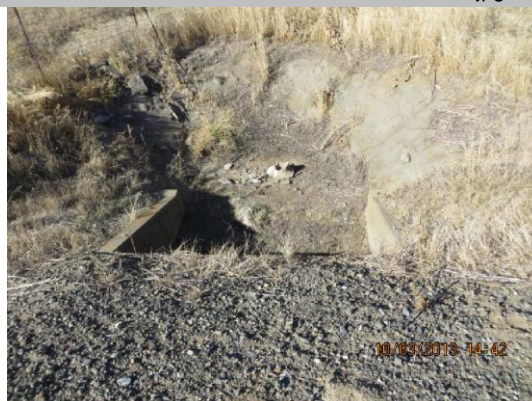
Photo 1 of 3 : UCIP_FA_2018_51443_37061.jpg

Comment Code					
Inspector Comment					
FS_ID:51443 DS_ID:20880 EP_NO: N/A Repair Type: Non-Urgent Crossing Status: Found UCIP Comments: 12/05/2016 Crossing has been downgraded from Urgent to Non-Urgent vegetation found on WS but does not appear to prevent proper function of flap gate. Recommend clearing dry vegetation on WS above concrete headwall.(O. Magana - DWR UCIP)10/03/2013 Flapgate operation hindered by soil and vegetation on WS toe. (W. Wylie - DWR UCIP) FIELD_STRUCT_DESC: 2 of 2: 36-inch corrugated metal drainage pipe through levee, 8.6 feet below crown. Flap gate and concrete "U" headwall located on the waterside (WS) end. Concrete "U" headwall located on the landside (LS) end. [Additional Reference(s): DWR Levee Log, 1992. USACE Sacramento O&M Manual, Unit 510, April 1963, As-built drawing No. 50-4-3622 (HLM 0.65)] FS Date: 12/5/2016

Concrete U-shaped headwall on LS toe.

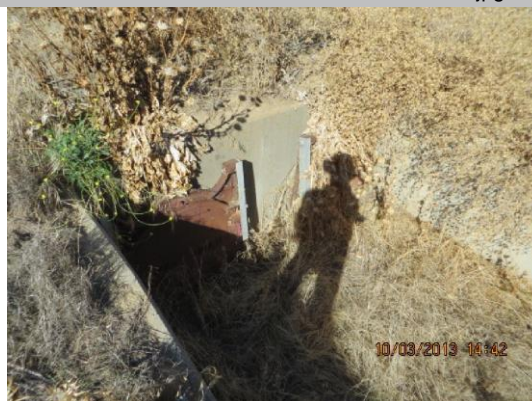
Photo 3 of 3 : UCIP_FA_2018_51443_37059.jpg

Comment Code						
Inspector Comment						
FS_ID:51443 DS_ID:20880 EP_NO: N/A Repair Type: Non-Urgent Crossing Status: Found UCIP Comments: 12/05/2016 Crossing has been downgraded from Urgent to Non-Urgent vegetation found on WS but does not appear to prevent proper function of flap gate. Recommend clearing dry vegetation on WS above concrete headwall.(O. Magana - DWR UCIP)10/03/2013 Flapgate operation hindered by soil and vegetation on WS toe. (W. Wylie - DWR UCIP) FIELD_STRUCT_DESC: 2 of 2: 36-inch corrugated metal drainage pipe through levee, 8.6 feet below crown. Flap gate and concrete "U" headwall located on the waterside (WS) end. Concrete "U" headwall located on the landside (LS) end. [Additional Reference(s): DWR Levee Log, 1992. USACE Sacramento O&M Manual, Unit 510, April 1963, As-built drawing No. 50-4-3622 (HLM 0.65)] FS Date: 12/5/2016

Concrete U-shaped headwall and flapgate on WS toe.

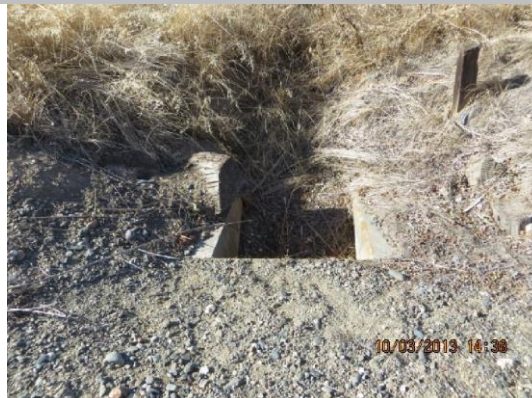
Photo 1 of 3 : UCIP_FA_2018_21790_37057.jpg

LM Start	0.75	Rating **	A/W	Issue No.	922
LM End	0.75	Issue Type +	Ma	Location *	
Category	Supplemental			GPS Latitude/Longitude	
				Start	End
Item	DWR UCIP LMA Responsibility			40.052194 °	40.052194 °
				-122.175390 °	-122.175390 °
DWR ID	20779				
Comment Code					
Inspector Comment					
FS_ID:21790 DS_ID:20779 EP_NO: N/A Repair Type: No Action Needed Crossing Status: Found UCIP Comments: FIELD_STRUCT_DESC: 24-inch corrugated metal drainage pipe through the levee, 5.8 feet below the crown. Flap gate and concrete U-shaped headwall on the waterside (WS) end. Concrete U-shaped headwall on the landside (LS) end. [Additional Reference(s): DWR Levee Log, 1992. USACE Sacramento O&M Manual 510, April 1963, (HLM 0.76) Drawing No. 50-4-3622]. FS Date: 10/3/2013

Concrete U-shaped headwall on LS toe.

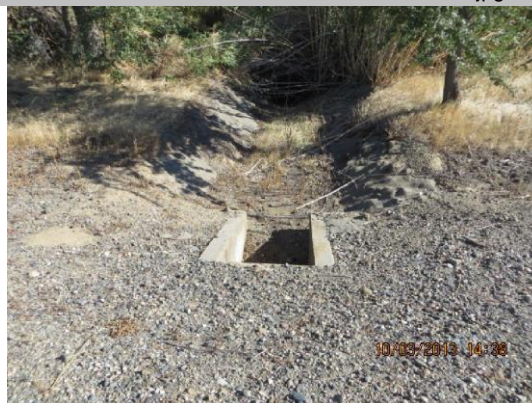
Photo 2 of 3 : UCIP_FA_2018_21790_37056.jpg

Concrete U-shaped headwall on WS toe.

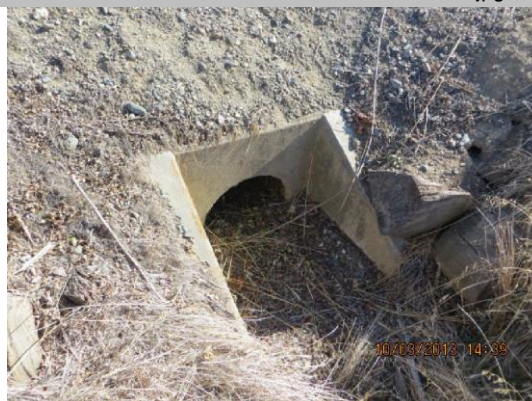
Photo 3 of 3 : UCIP_FA_2018_21790_37055.jpg

Concrete U-shaped headwall on LS toe.

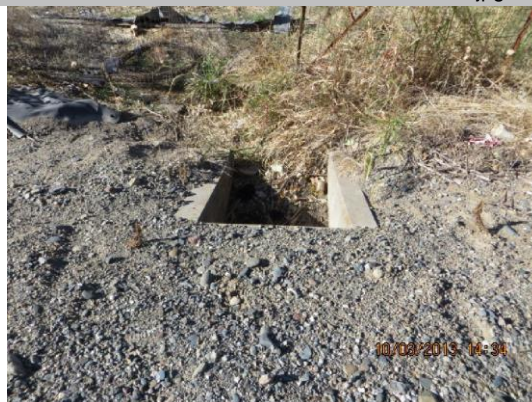
Photo 1 of 3 : UCIP_FA_2018_22827_38970.jpg

LM Start	0.91	Rating **	A/W	Issue No.	923	
LM End	0.91	Issue Type +	Ma	Location *		
Category	Supplemental			GPS Latitude/Longitude		
				Start		End
Item	DWR UCIP LMA Responsibility			40.053401 °		40.053401 °
				-122.172848 °		-122.172848 °
DWR ID	20780					
Comment Code						
Inspector Comment						
FS_ID:22827 DS_ID:20780 EP_NO: N/A Repair Type: No Action Needed Crossing Status: Found UCIP Comments: FIELD_STRUCT_DESC: 24-inch corrugated metal drainage pipe through the levee, 4.5 feet below the crown. Flap gate and concrete U-shaped headwall on the waterside (WS) end. Concrete U-shaped headwall on the landside (LS) end. [Additional Reference(s): DWR Levee Log, 1992. USACE Sacramento O&M Manual 510, April 1963, (HLM 0.93) Drawing No. 50-4-3622]. FS Date: 10/3/2013

Concrete U-shaped headwall on LS toe.

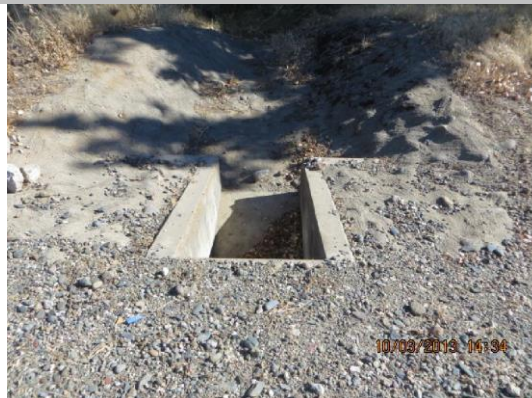
Photo 2 of 3 : UCIP_FA_2018_22827_38969.jpg

Concrete U-shaped headwall on WS toe.

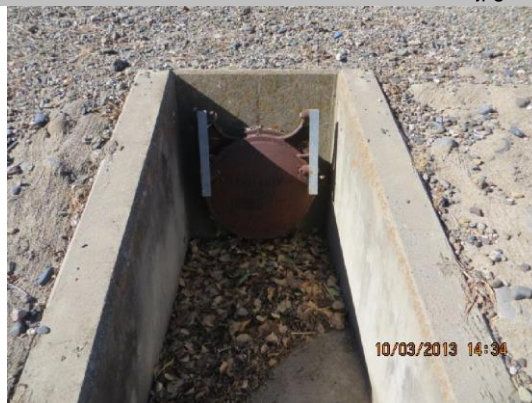
Photo 3 of 3 : UCIP_FA_2018_22827_38972.jpg

Flapgate on headwall at WS toe.

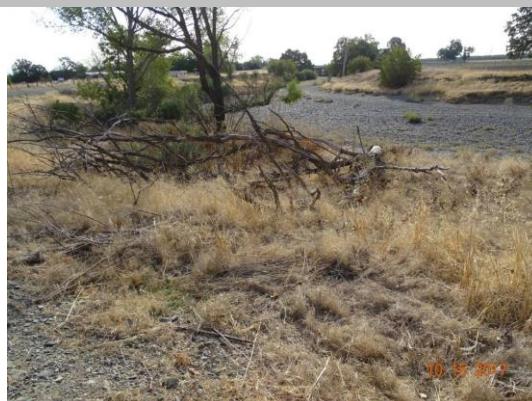
Photo 1 of 1 : FA_2018_NA0019_81_50_20180905_00022.jpg

LM Start	0.92	Rating **	M	Issue No.	50
LM End	0.92	Issue Type +	Ma	Location *	WS
Category	Earthen Levee			GPS Latitude/Longitude	
				Start	End
Item	Encroachments			40.053420 °	40.053420 °
				-122.172617 °	-122.172617 °
DWR ID	DWR_NA0019_04_f_2017_50				
Comment Code					
TR : Tree or limb					
Inspector Comment					
Remove the tree from the waterside toe.

View of the tree along waterside toe.
